TNR153856 - Norfolk Southern Intermodal Facility Photos

Permit No.:	Site Location:	Permittee:	Date:	Time On-Site
TNR153856	3000 Norfolk Southern Way, Rossville, Fayette Co., TN	Norfolk Southern Railway	May 6, 2015	09:39 AM

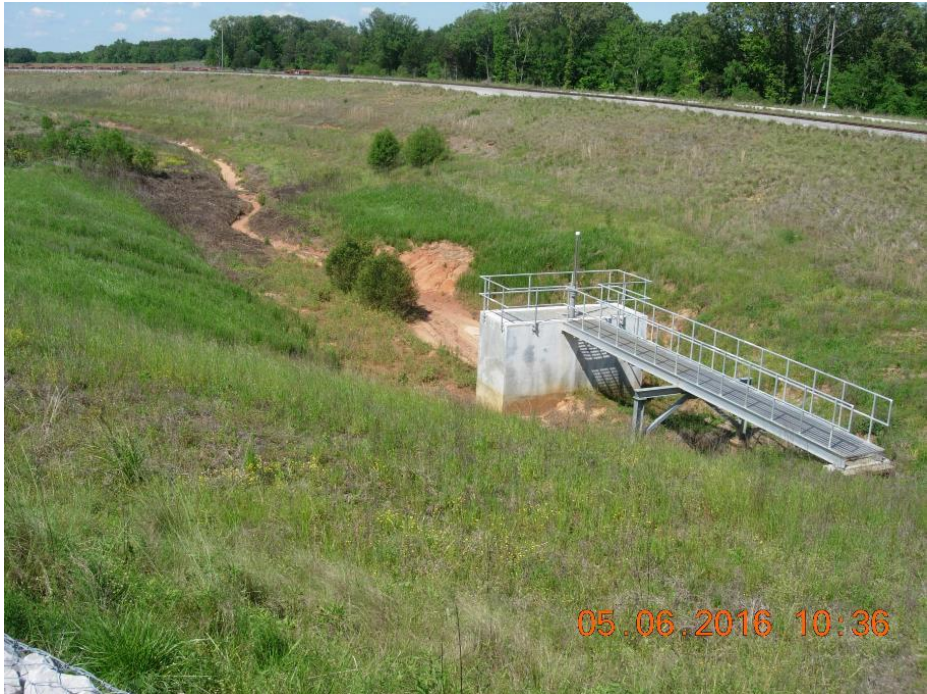
1	Cliff Caudle	
Description View southwest across Permanent Basin 4 (previously sediment basin 1). Upper and medial side slopes of Basin 4 were mostly well-vegetated; the low-flow channel had a sandy bottom. Erosion and gullies were observed around the slotted box outfall structure. Reddish-brown staining was observed on the outfall structure indicating sediment-laden water may have risen several ft. in the basin, creating potential for discharge to SW9 & Stream 5.

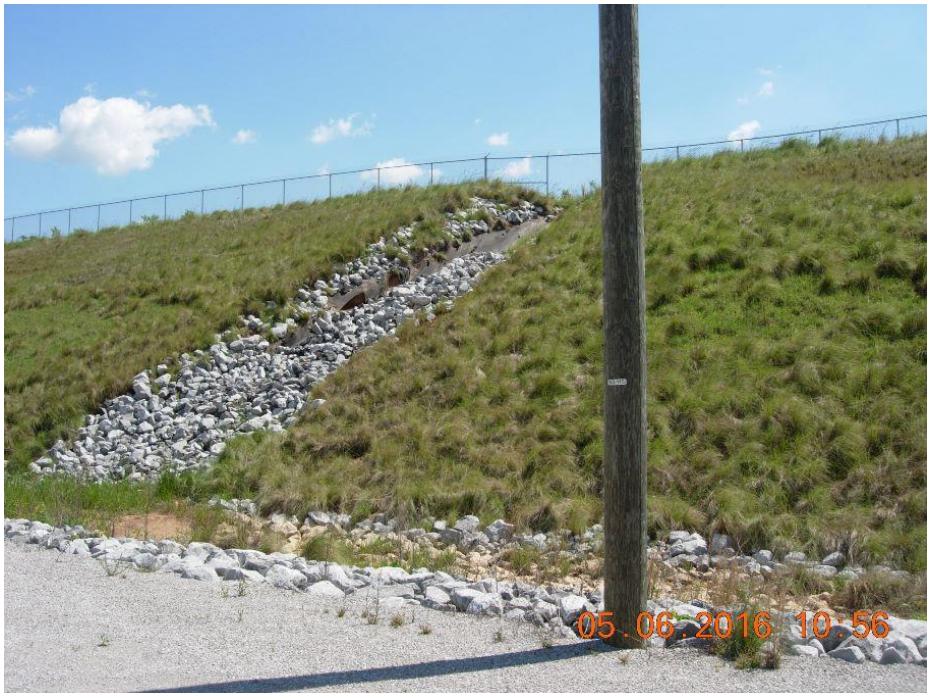
2	Cliff Caudle	
Description View northeast showing a rip-rap flume down the large eastern slope that had failed near light pole 115. As a result, sediment had accumulated in the eastern conveyance.

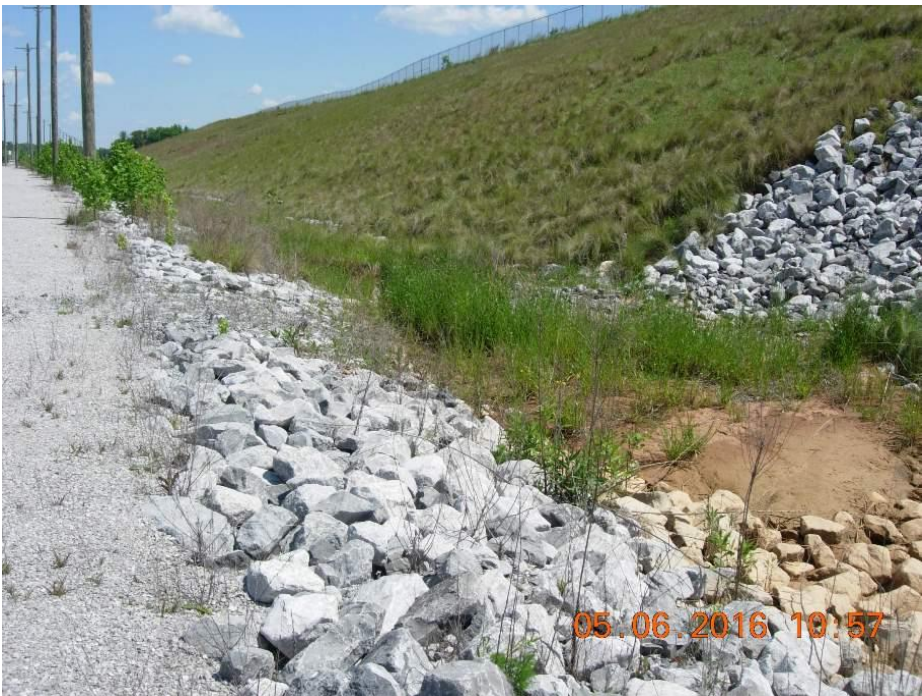
3	Cliff Caudle			
Description				
View northeast showing the sediment accumulation in the eastern conveyance below the rip-rap flume near light pole 115.

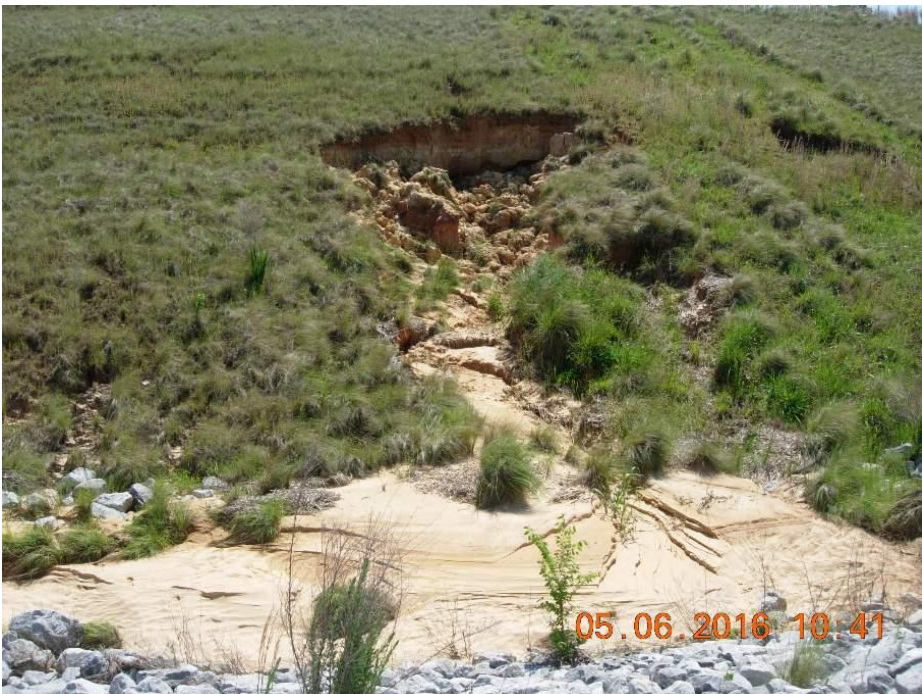
4	Cliff Caudle			
Description				
View east showing a slump slope failure that had occurred near light pole 125. As a result, sediment had accumulated in the eastern conveyance below the slump.

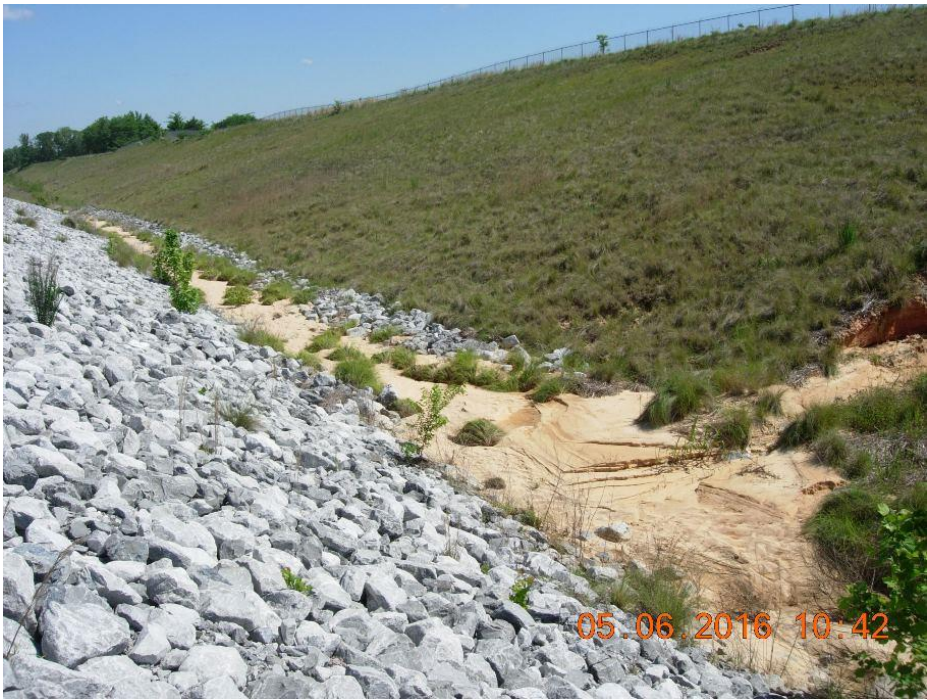
3	Cliff Caudle			
Description				
View northeast showing sediment accumulation in the eastern conveyance below the slump slope failure shown in photo 2.

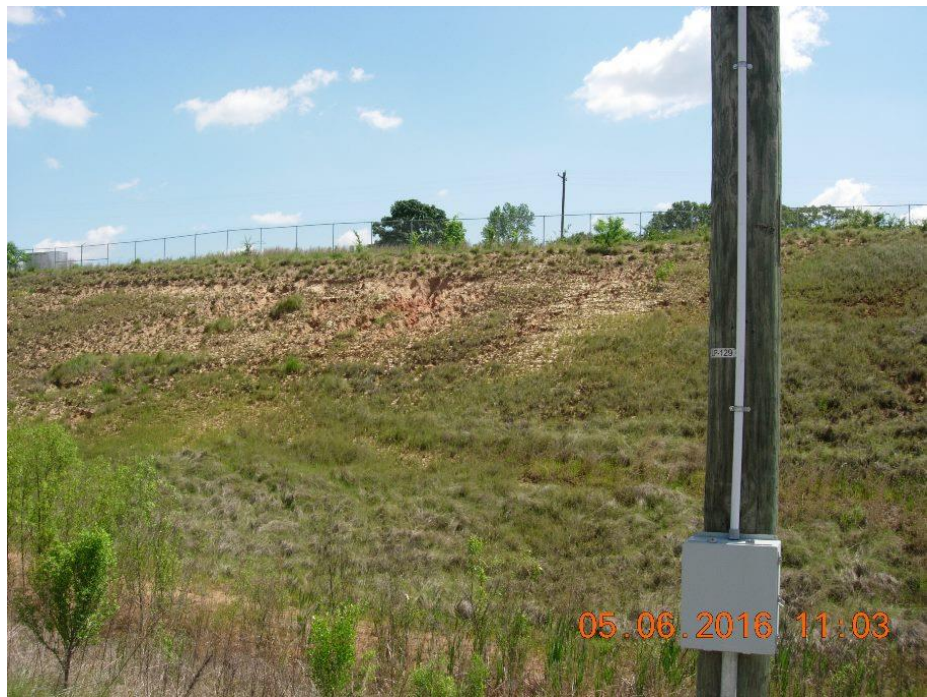
6	Cliff Caudle			
Description				
View eastward showing a large, sparsely vegetated area in the vicinity of light pole 129 above the eastern conveyance.
